**Subject:** Consideration and proposed approval of a resolution approving Contract Change Order No. 4 to the Construction Contract for Bell Canyon Reservoir – Install New Frame and Sluice Gate on Water Intake Tower, CIP Project W-84, with DRS Marine, Inc. in the amount of \$31,922 to DRS Marine Inc. for critical repairs of the upper valve at Bell Canyon Reservoir Intake Tower

BELL CANYON UPPER VALVE & SCOUR VENT

RE: Bell Canyon upper valve & scour vent

RE: Upper valve inspection

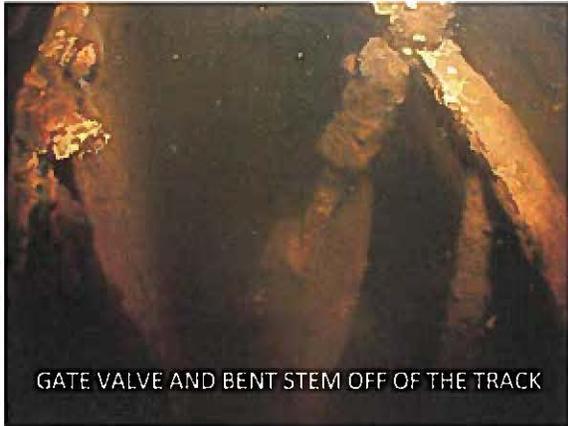
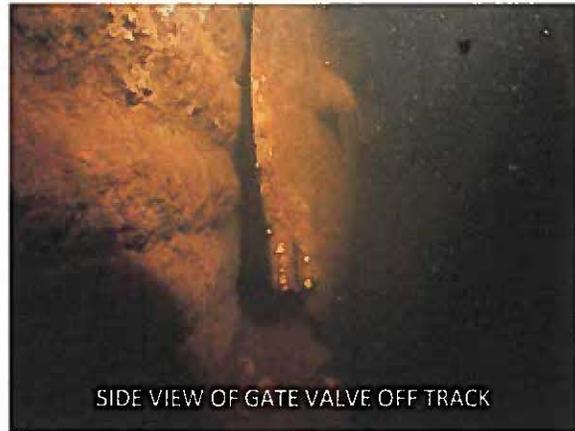
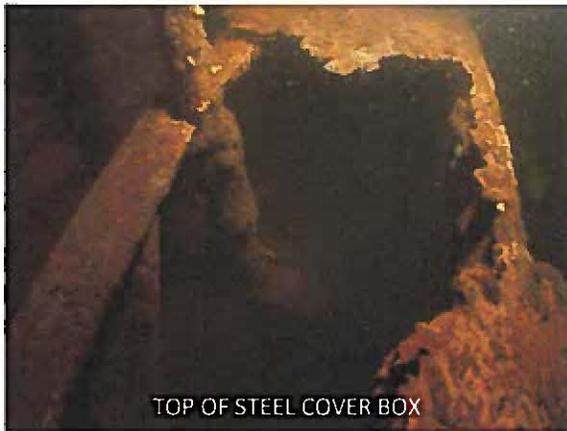
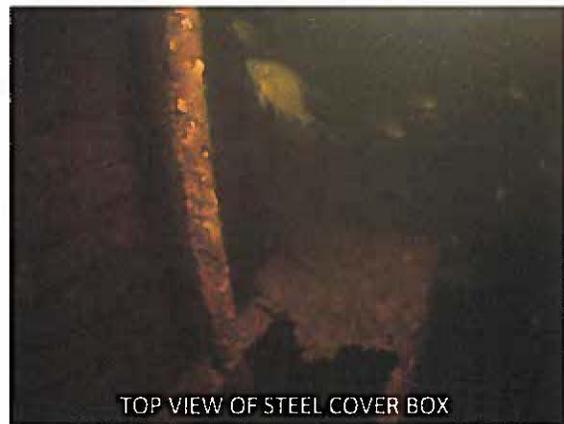
## 1.0 UPPER VALVE

The upper valve is totally inoperable and out of its tracks. The valve stem is bent and the steel cover box and riser pipe extension are totally rotten leaving the inlet of the tower totally exposed to the open water where fish and debris can get in the water system.

- Remove rotten cover box and riser pipe
- Remove gate valve and bent stem
- Repair gate guides and get gate functioning again
- Repair stem and adjust stem guides
- Install a screen over valve
- Remove rotten scour valve vent pipe and replace it with new pipe

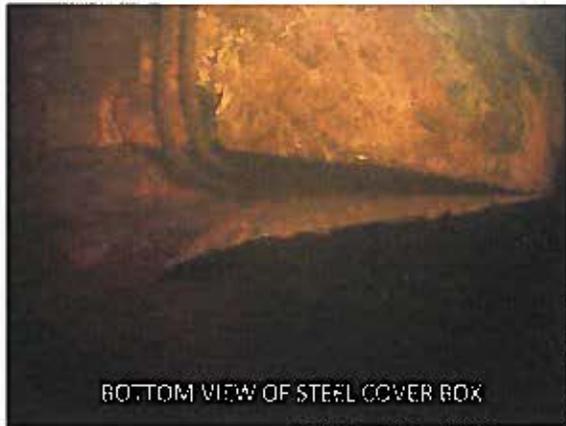
BOTTOM VIEW OF STEEL COVER BOX

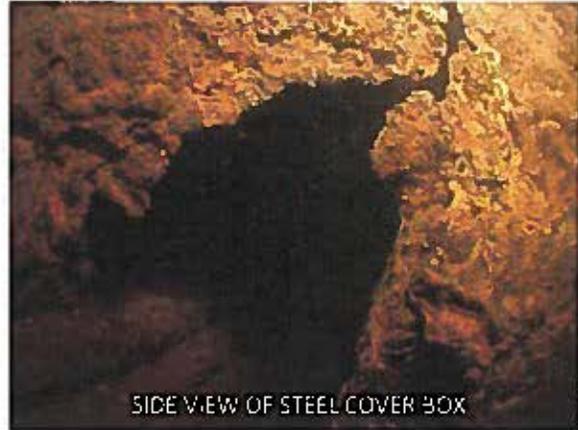
SIDE VIEW OF STEEL COVER BOX

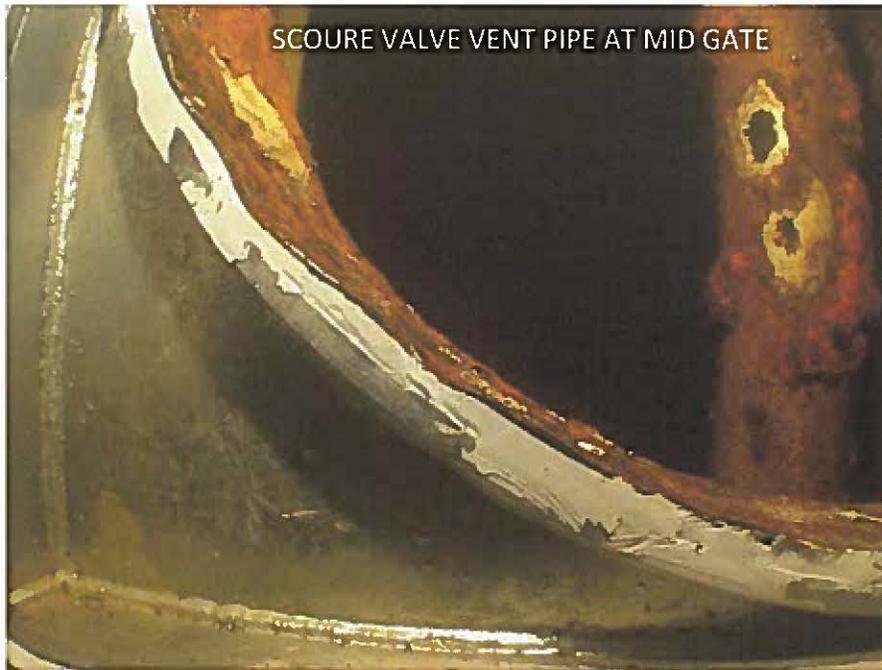
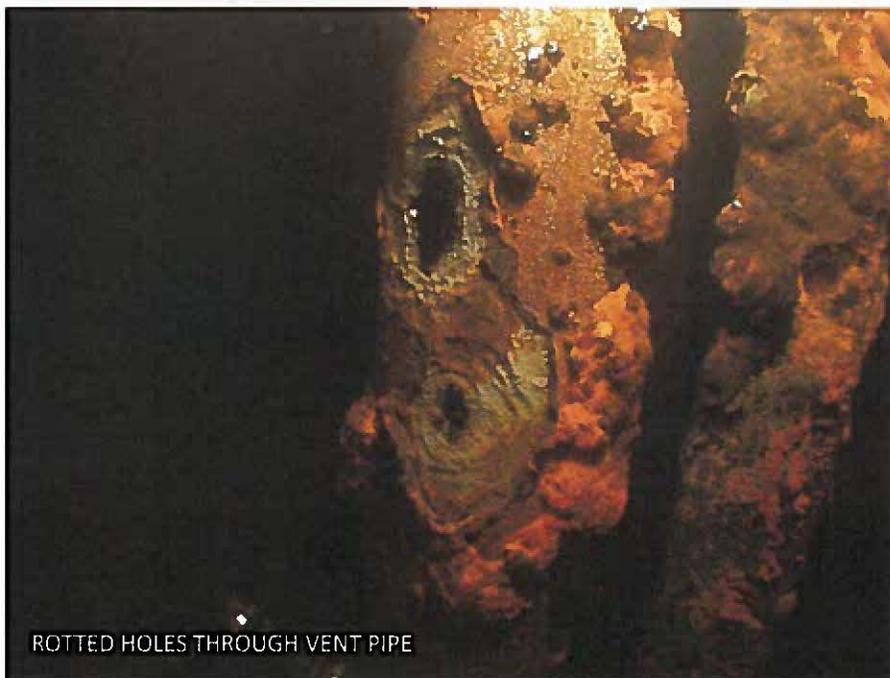
## 2.0 Scour Valve vent pipe

The Scour valve vent pipe is badly corroded with rot holes. These holes make it so the scour valve outlet pipe would never be able to be dewatered because of the leakage in the vent pipe behind the valve.

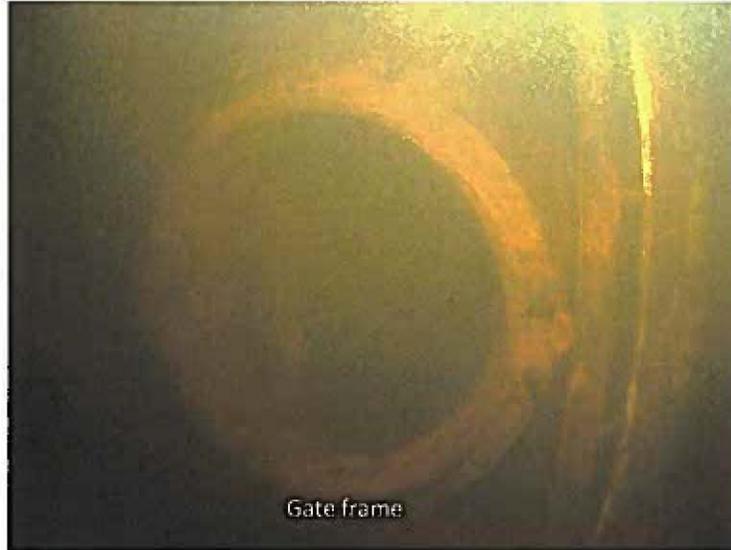
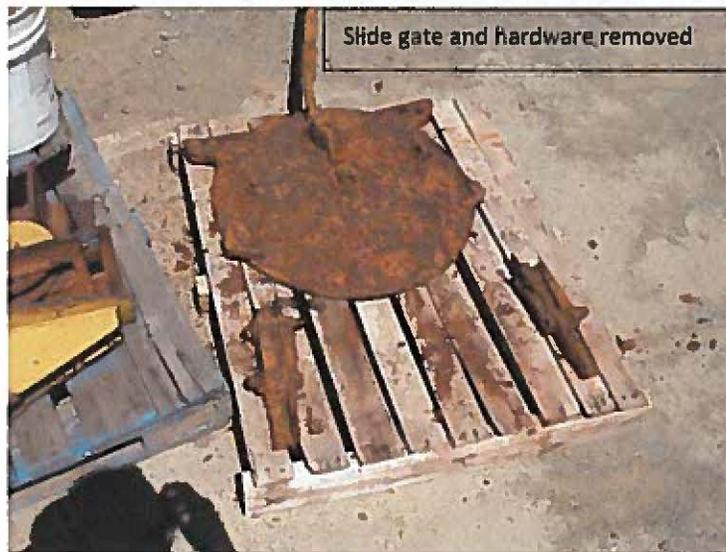
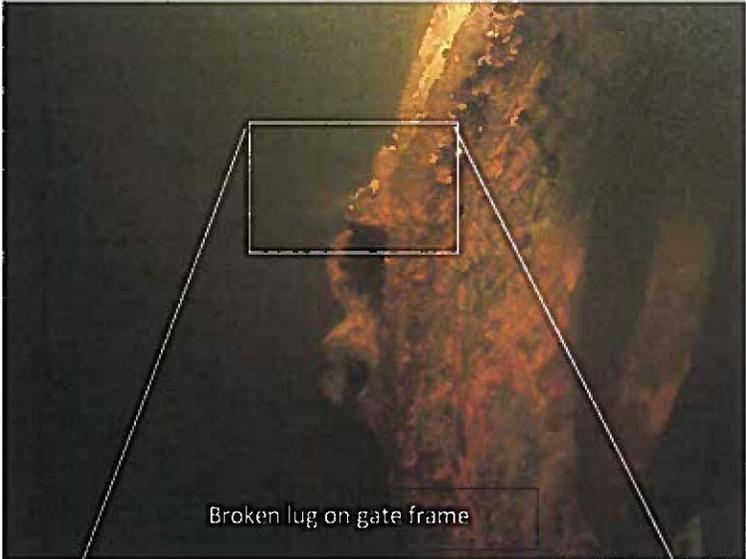
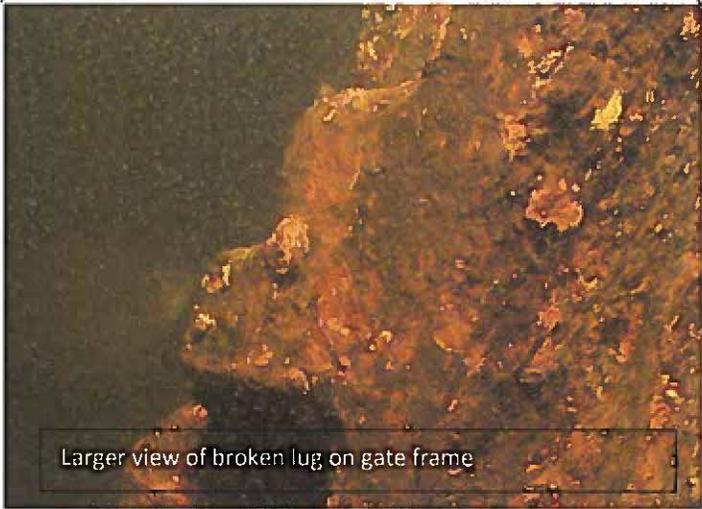
## 1.0 Gate Valve

All the hardware of the gate valve was removed except the frame. The frame had one broken lug that could be repaired. The rest of the gate can be refurbished or replaced.

Following DRS Marine's full inspection (included as Attachment 3) it was determined that the upper valve could be repaired and DRS Marine provided a quote for rebuilding the valve. This includes repairing one broken lug on the valve frame, refurbishing the slide gate and guides, epoxy patching corrosion holes on the stem pipe, and replacing the scour valve pipe. DRS Marine's quoted price for this work \$31,922.

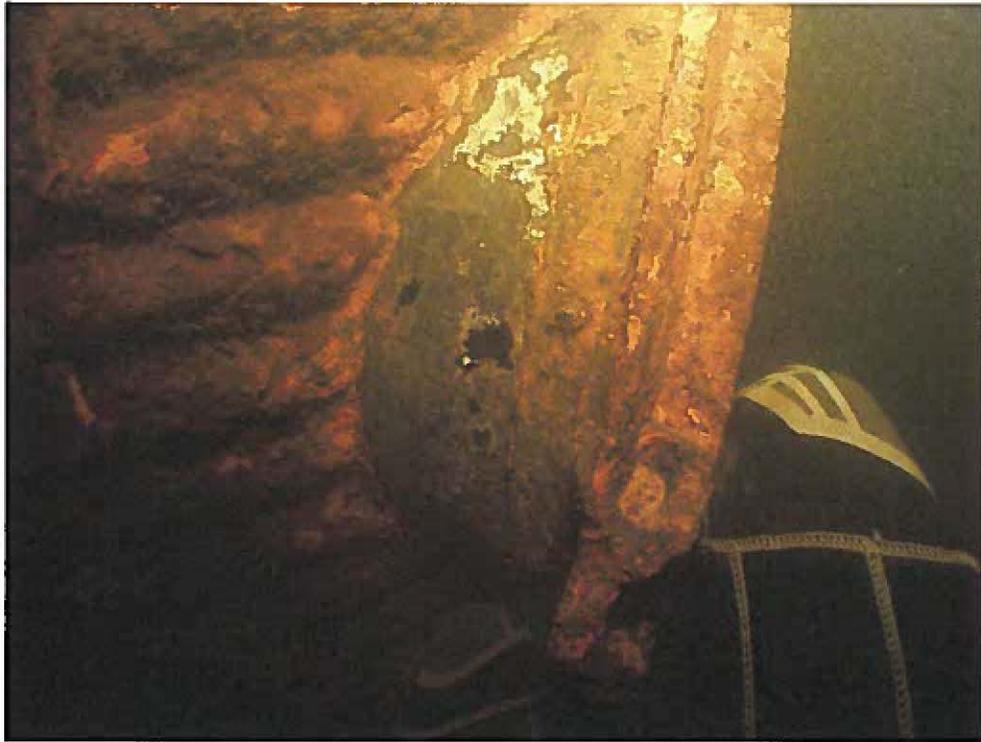
## 2.0 Stem Pipe

The stem pipe coming out of the tower has some corrosion holes at the 8 o'clock position but the rest of the pipe appears to be intact. These holes can be repaired with epoxy.

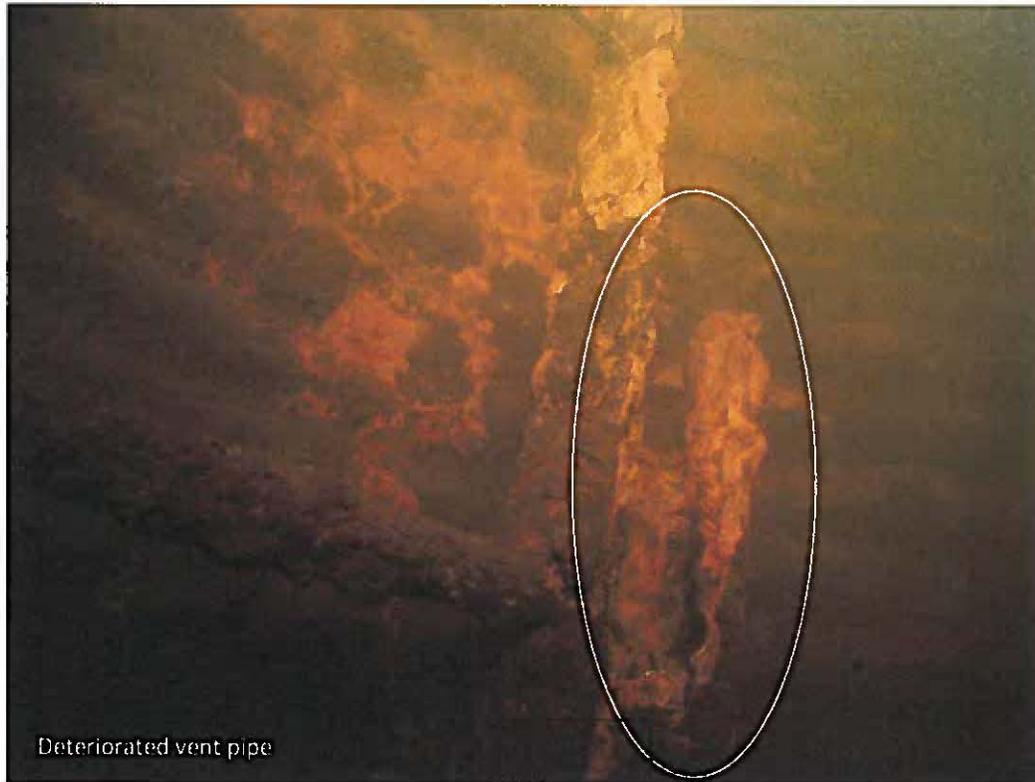
### 3.0 Scour Valve Vent Pipe

During the inspection it was found that the vent pipe was completely deteriorated. This prevents the capability of dewatering the scour valve pipe.
